To cite this article: Belén Zurro García *et al* 2020 *IOP Conf. Ser.: Earth Environ. Sci.* **410** 012104

# Comparison of theoretical heat transfer model with results from experimental monitoring installed in a refurbishment with ventilated facade

In November 2017, the renovation of the demonstration building was carried out in the Building 3 of the Faculty of Nursing and Health Sciences of the University of Burgos (former Military Hospital), located in the city of Burgos, in Spain, with a moderate continental climate.

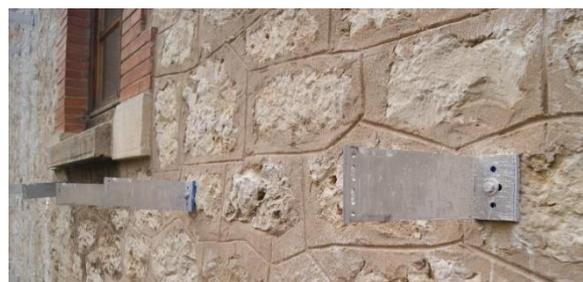
The renovation works of the building began with the redefinition of the facade, marking the position of the five rows of anchors to be placed on the external surface. Subsequently, and in the delimited position, the necessary L-shaped brackets were placed to support the vertical profiles.

**Figure 1.** Metal brackets for fixing vertical profiles.

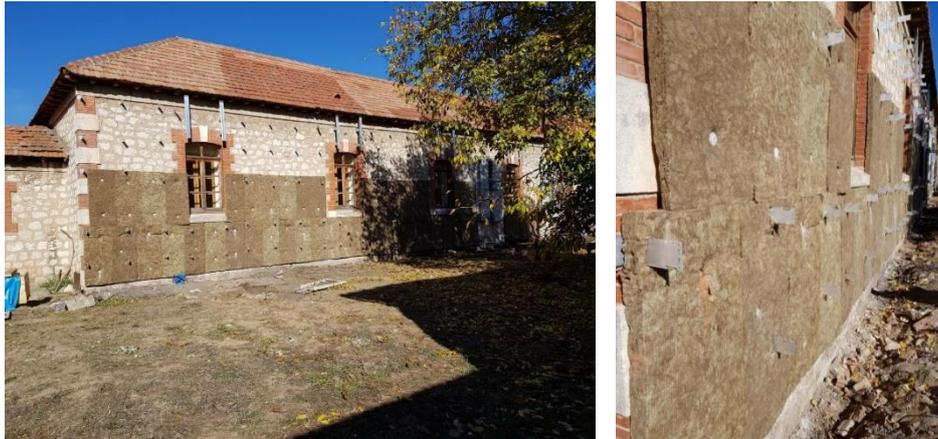
Thermal insulation was installed on the outside, consisting of two layers of mineral wool with thickness of 7,5 cm, making a total of 15 cm. These layers were fixed to the wall mechanically using fasteners.

**Figure 2.** Installation of thermal insulation.

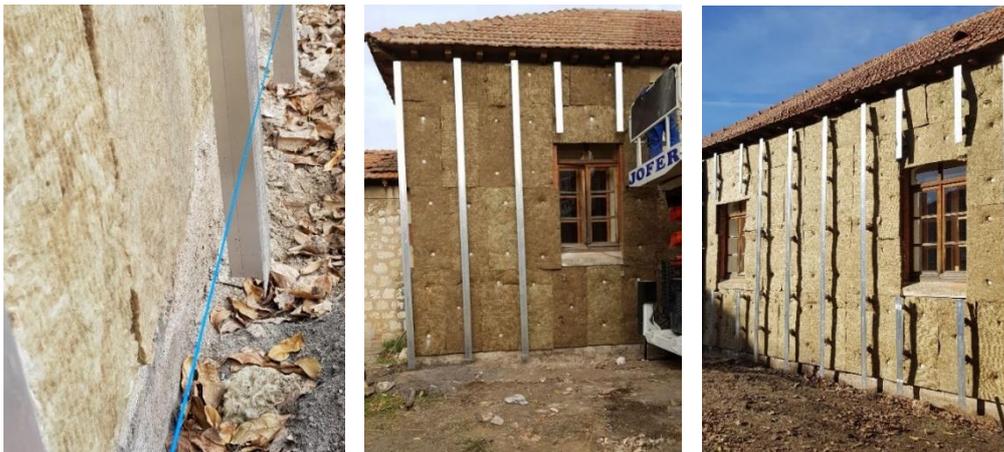
The next step in the execution of the renovation was the placement and plumb of the vertical profiles. These profiles were fixed to the previously installed brackets, firstly through their dovetail and later with screws.

**Figure 3.** Placement and plumb of the vertical profiles.

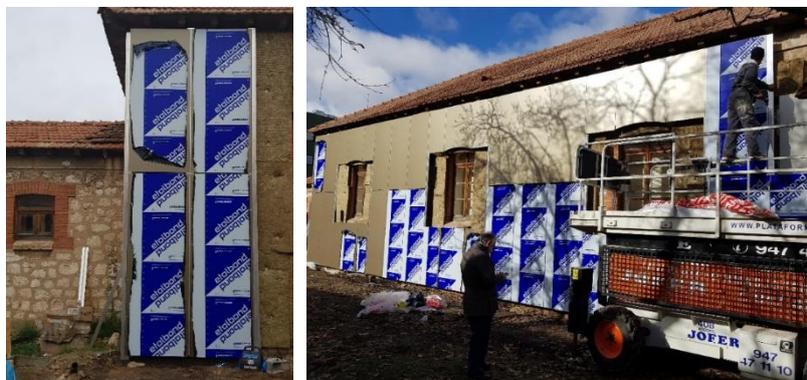
Finally, the final cladding of the façade, consisting of aluminum composite panels, was placed. Horizontal and vertical gaps with a width of 15 mm joint were left between the panels.

**Figure 4.** Final cladding placement.

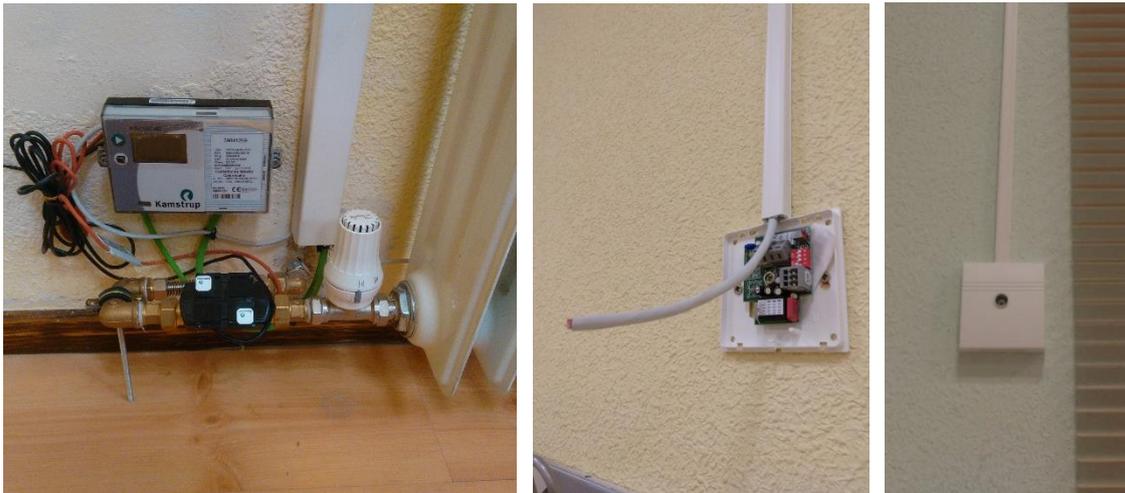
As mentioned, as part of the project, an advanced monitoring system was also installed, with multifunctional systems that monitor the environmental conditions both inside and outside. Among the data obtained are indoor and outdoor temperatures, relative humidity and CO<sub>2</sub> content [13], among others. The first of these is the most relevant for this study.

In addition, flow meters were also placed in the boilers for the control and regulation of the heating and the set point temperature.

**Figure 5.** Installed monitoring devices.

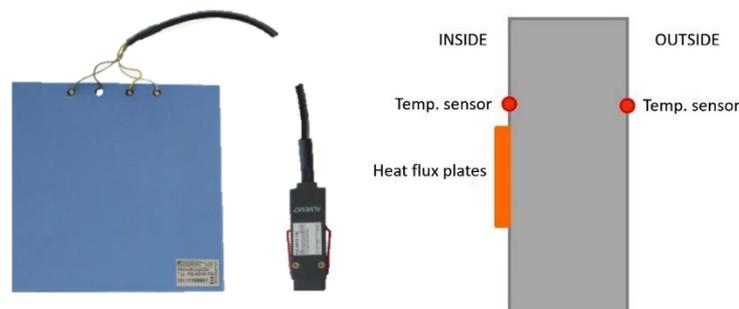
To complete the monitoring installed under the E2Vent project, for the realization of this analysis, a series of sensors has been installed on the north facade of the building, both in the renovated part and in the part that maintains the original state of the walls. Four temperature sensors have been placed, two on the inside of the wall and two on the outside, aligned with the previous ones. In addition, and considering that the purpose of this analysis is to check the heat flow in the enclosure, two heat flow meters are placed inside the classrooms.

**Figure 6.** Heat flow meter and position of the sensors.

The measuring devices have been placed on flat surfaces and away from encounters with other enclosures, that is, in areas where the values obtained are not affected by linear or point thermal bridges, following the indications of ISO 9869-1:2014 [6].

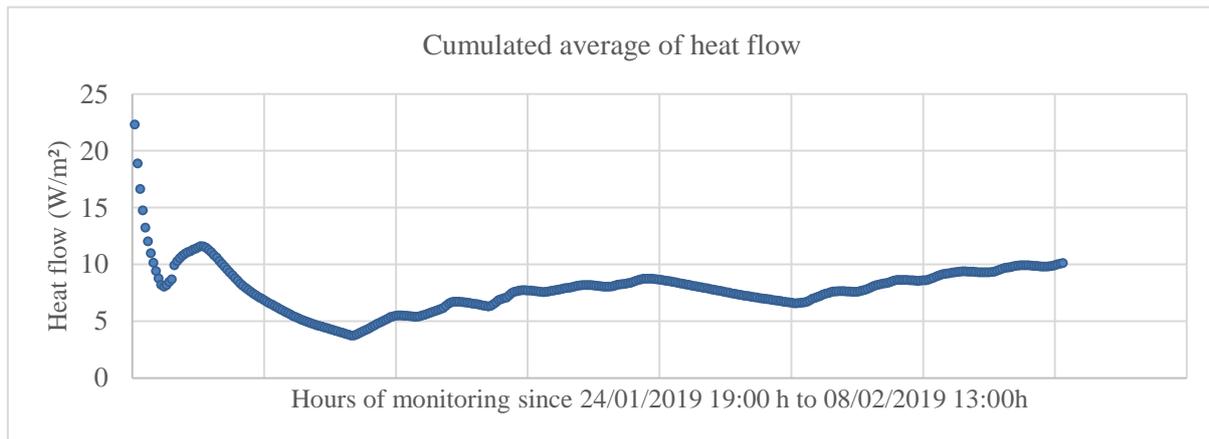
Once the data obtained from the sensors have been stored and studied, the hourly values of temperature ( $^{\circ}\text{C}$ ) and heat flow ( $\text{W}/\text{m}^2$ ) have been extracted and their cumulative average has been calculated. In such a way that the value of the average heat flow of the days in which the monitoring has taken place (from January 24 to February 8, 2019) has been obtained.

**Figure 7.** Cumulated average of heat flow.

On the other hand, from the data obtained after two weeks of monitoring, the resulting heat transfer coefficient in that same enclosure is 192.6 W/K.

As explained in the previous section, monitoring has also been carried out in the wall where no intervention was made in the E2Vent project, that is, the one that maintains its original state. Performing the same analysis as in the previous case, a heat transfer coefficient of 268.1 W/K is obtained.
